# **Residential Electrical System Aging Research Project**

## **Technical Report**

July 1, 2008

Prepared by:  
David A. Dini, P.E.  
Underwriters Laboratories Inc.

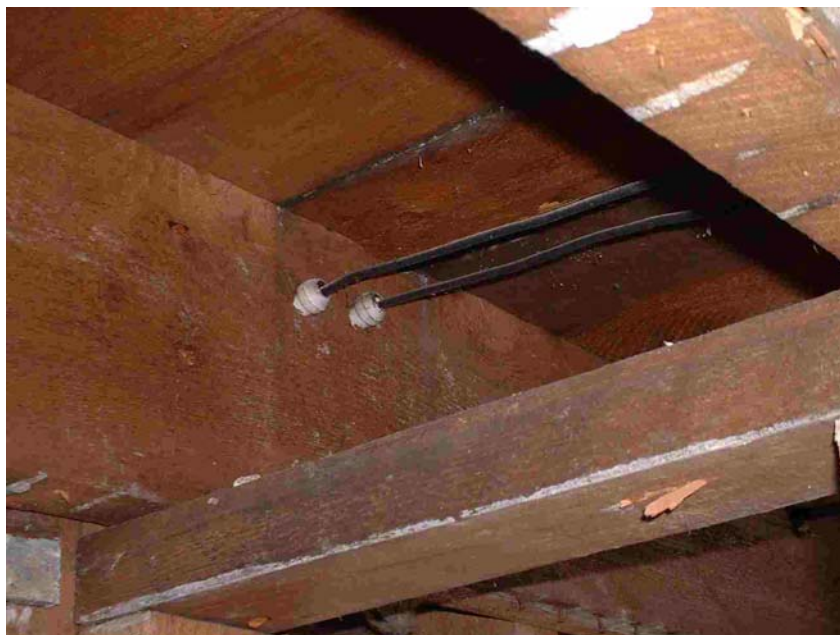
Fig. 1a – Knob-and-Tube Wiring From House IL-6

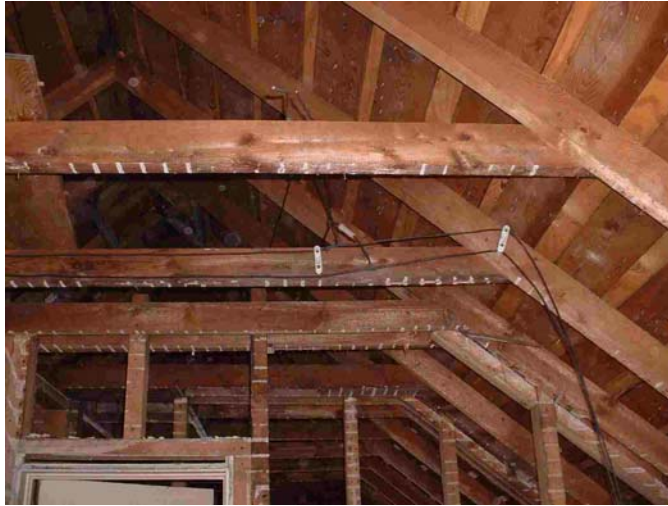
Fig. 1b – Knob-and-Tube Wiring From House IL-6

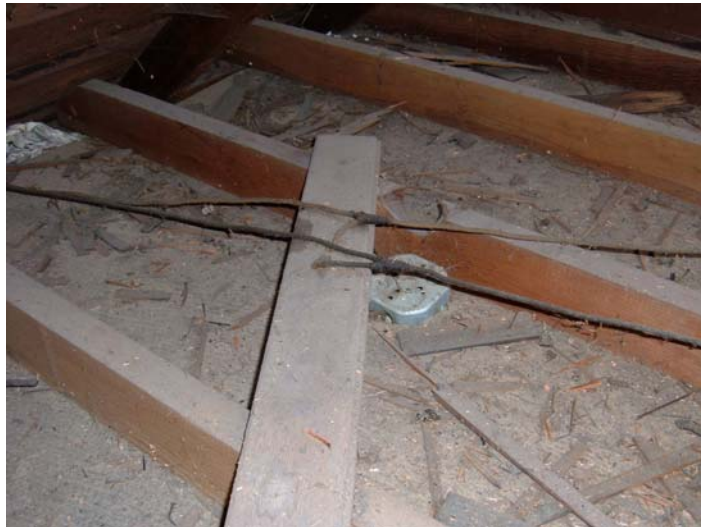
Fig. 2 – Knob-and-Tube Wiring From House OR-1

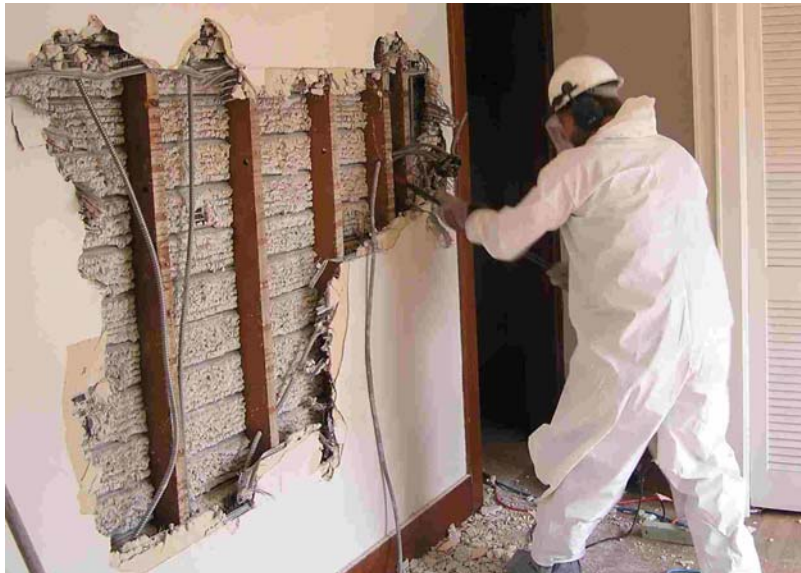
Fig 3 – Old Armored Cable Being Removed From House IL-1

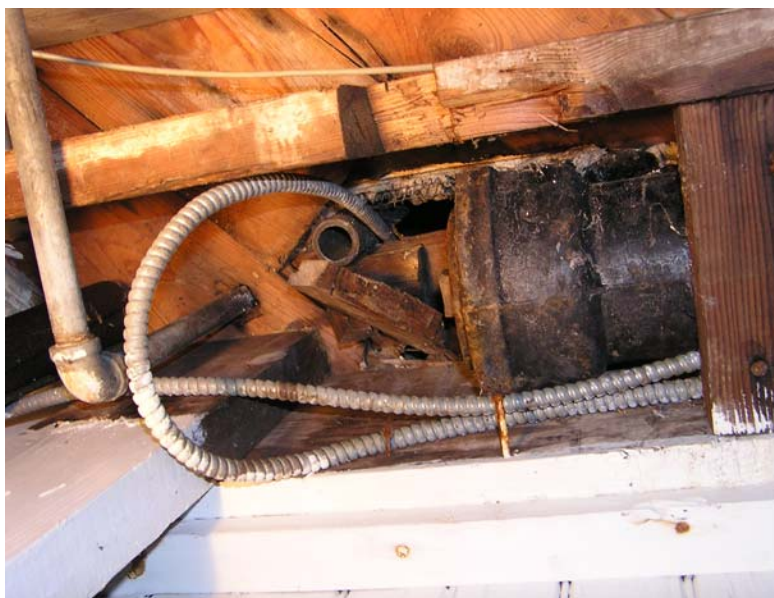
Fig 4 – AC Cable From Basement of House IL-1 With Some Corrosion

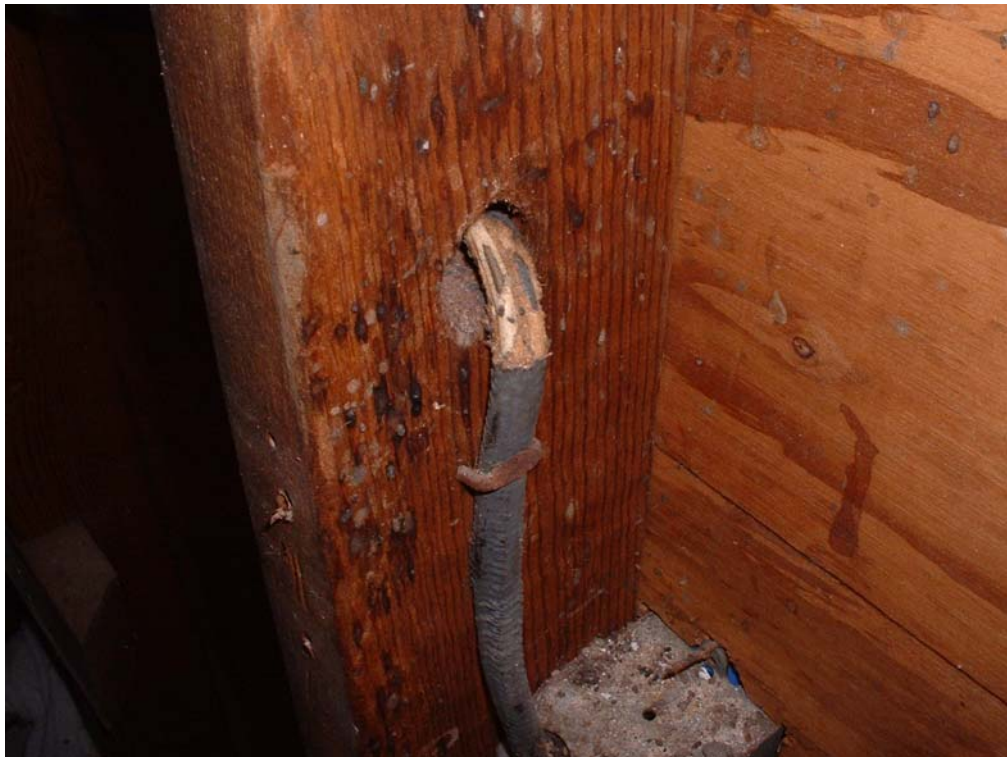
Fig. 5 – Old NM Cable From House AL-3 With Damaged Jacket

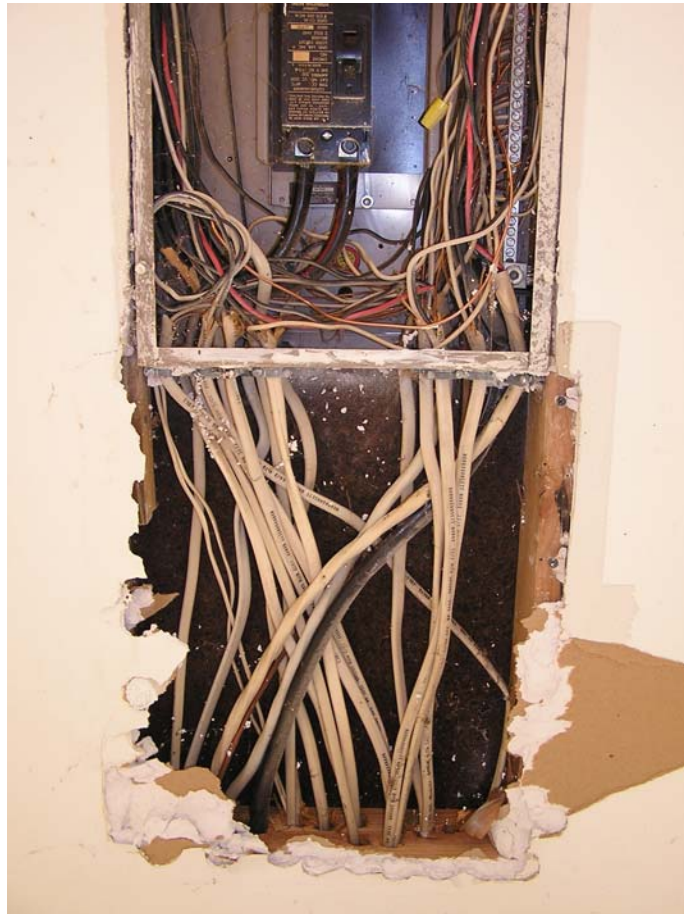
Fig. 6 – NM Cables From House VA-3

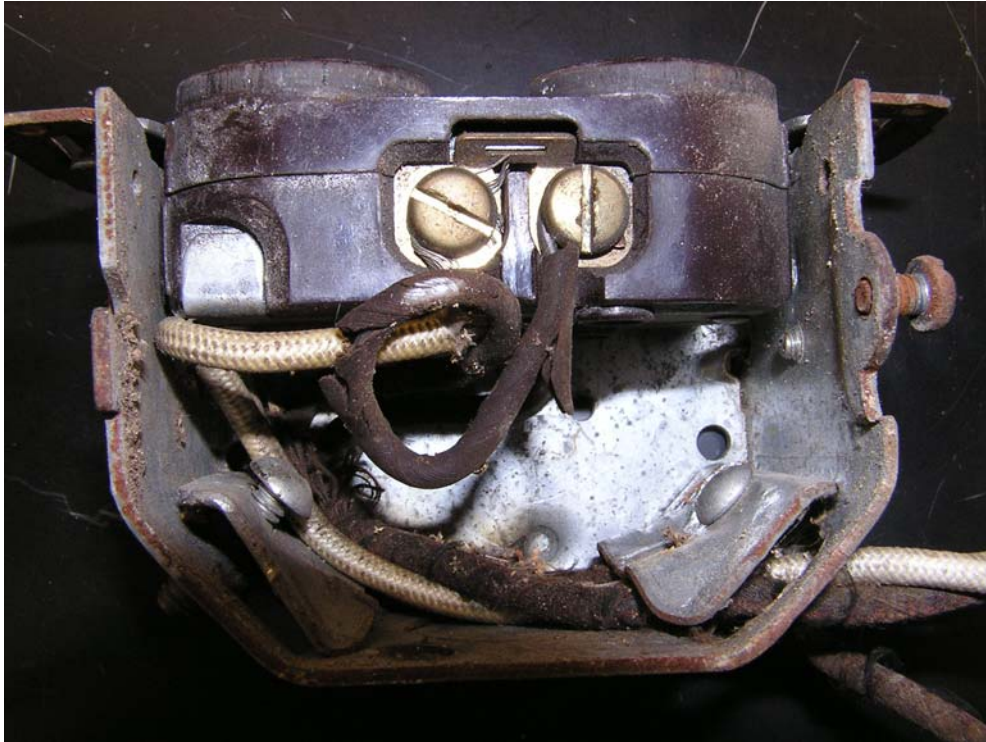
Fig. 7 – Brittle Conductor Rubber Insulation From House AL-7

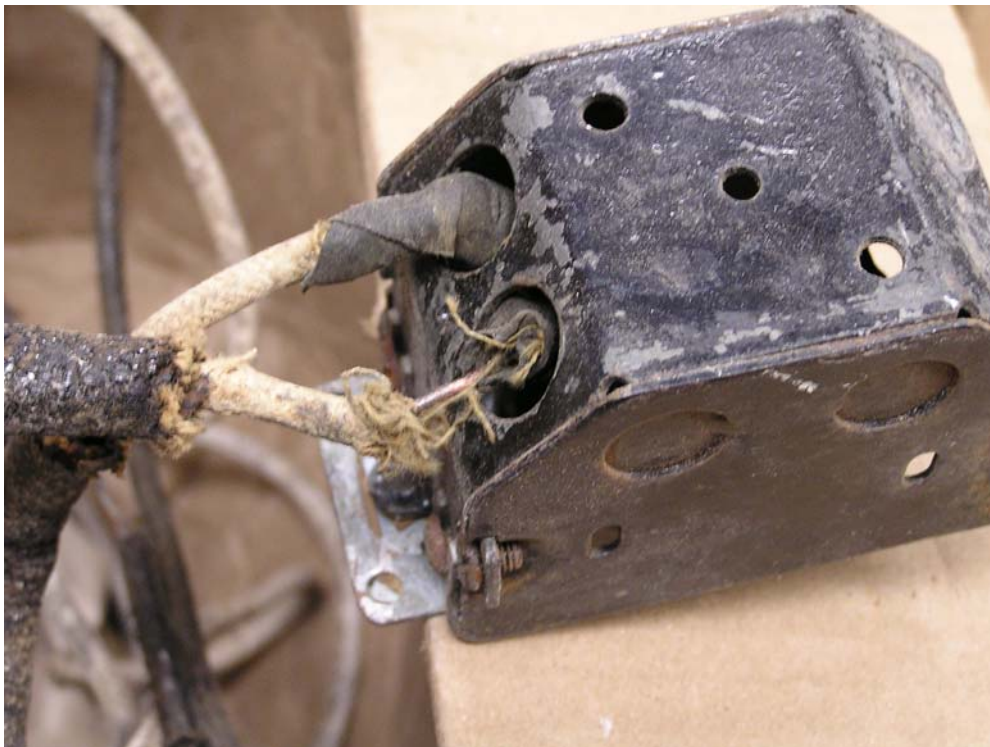
Fig. 8 – Brittle Knob-and-Tube Wire From House TX-2

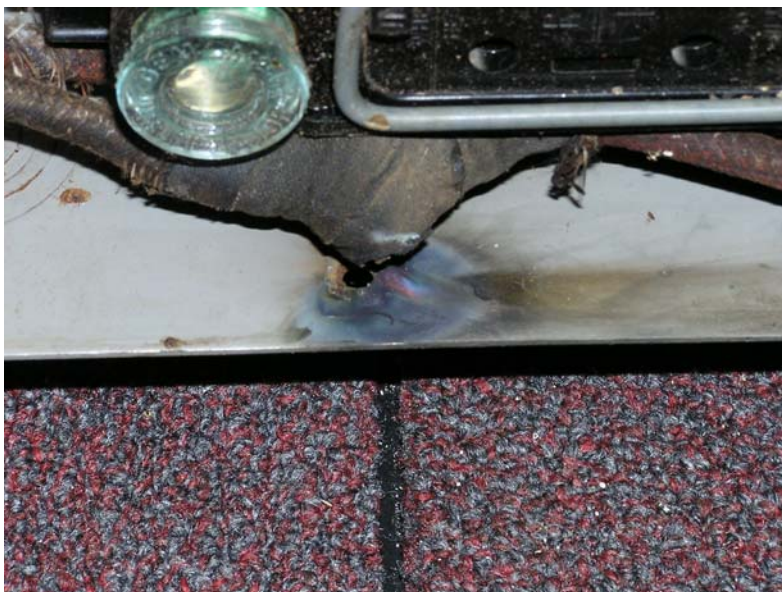
Fig. 9 – Arcing at Conductor Splice at House WI-1

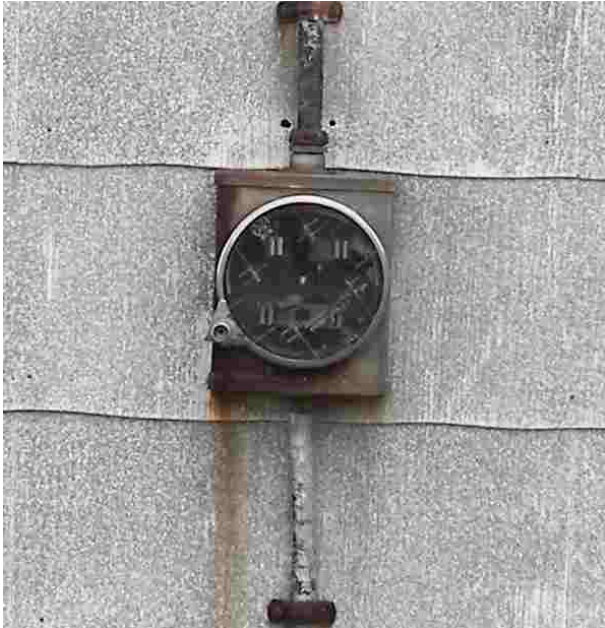
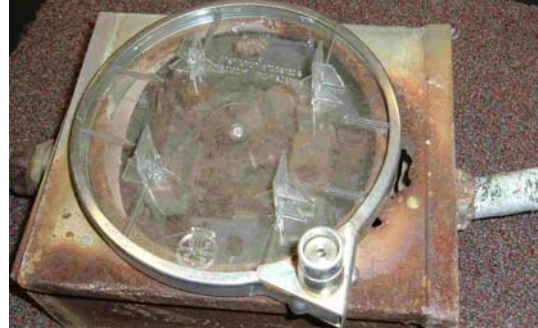
Fig. 10 – Meter Socket With Corrosion From House NY-1

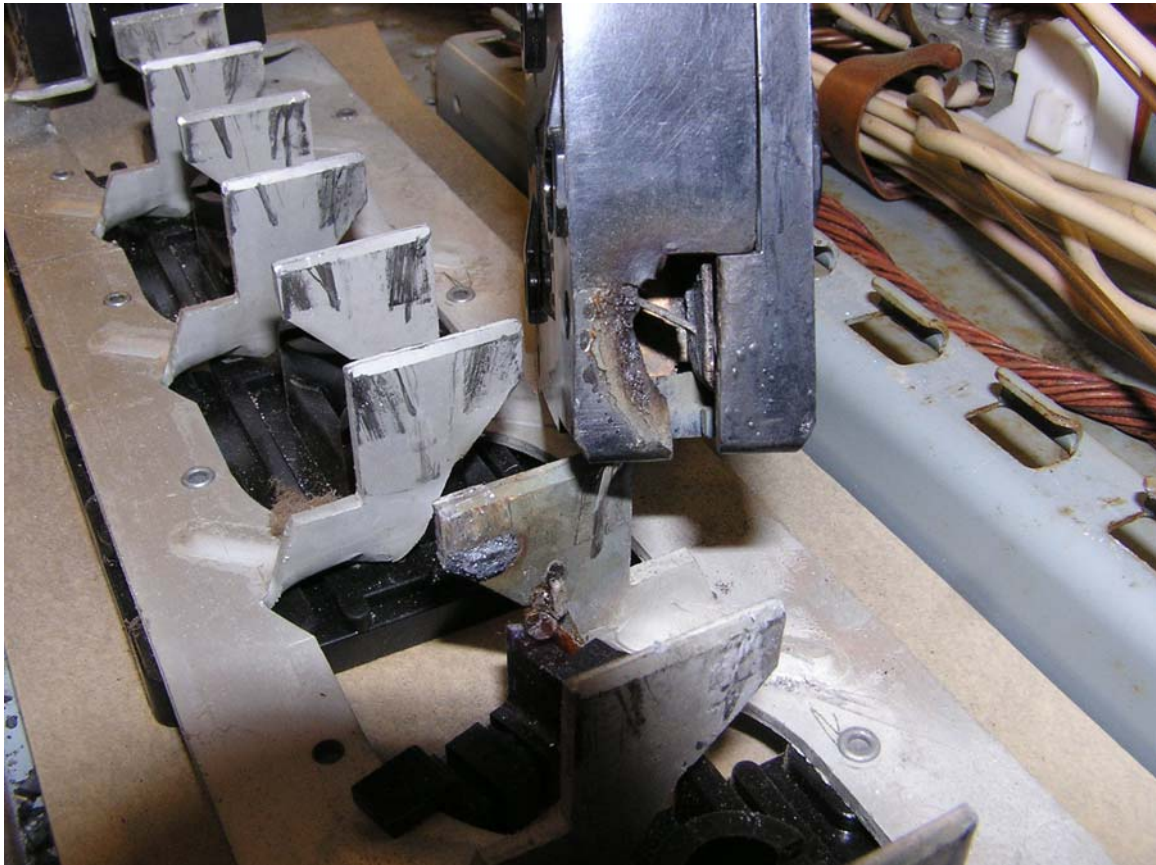
Fig. 11 – Arcing Damage at Breaker Stab at House MA-3

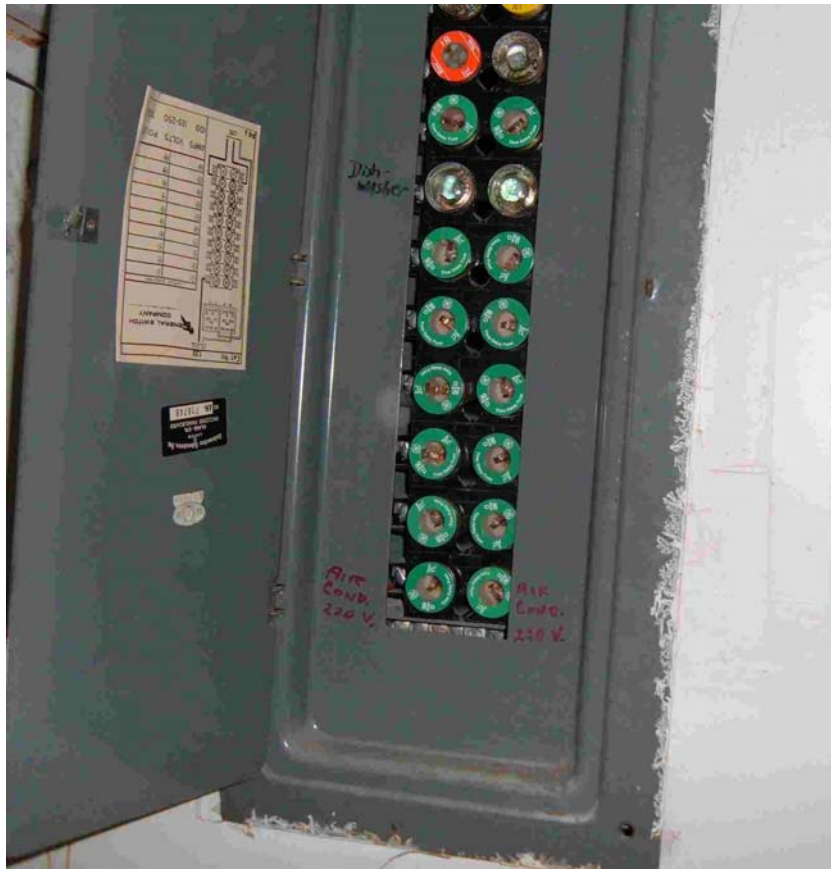
Fig. 12 – 30 Amp Fuses From House AL-8

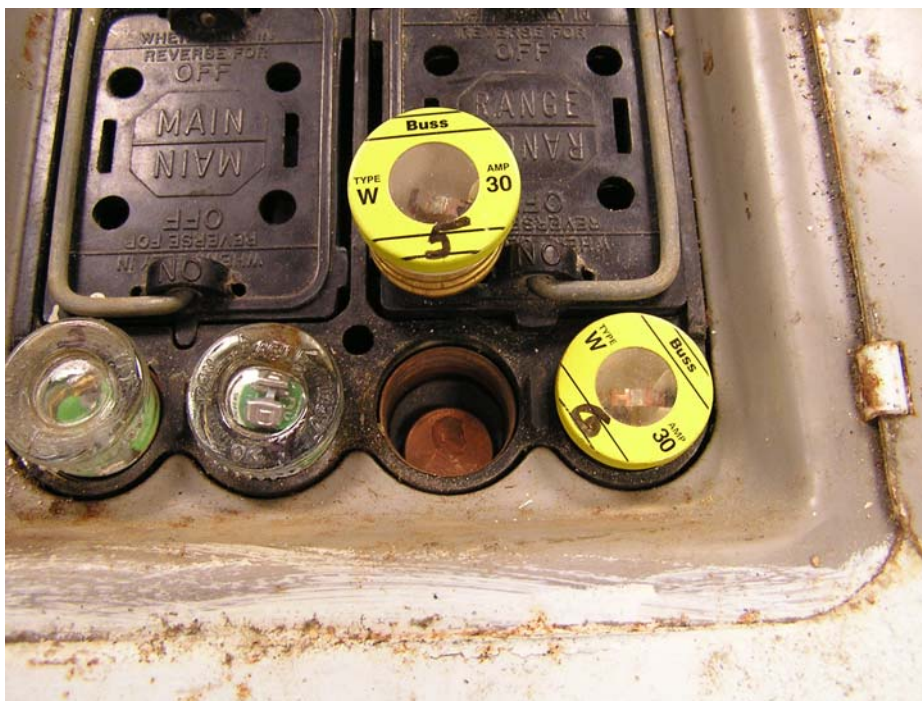
Fig. 13 – Penny Found Behind Blown Fuse at House AL-9

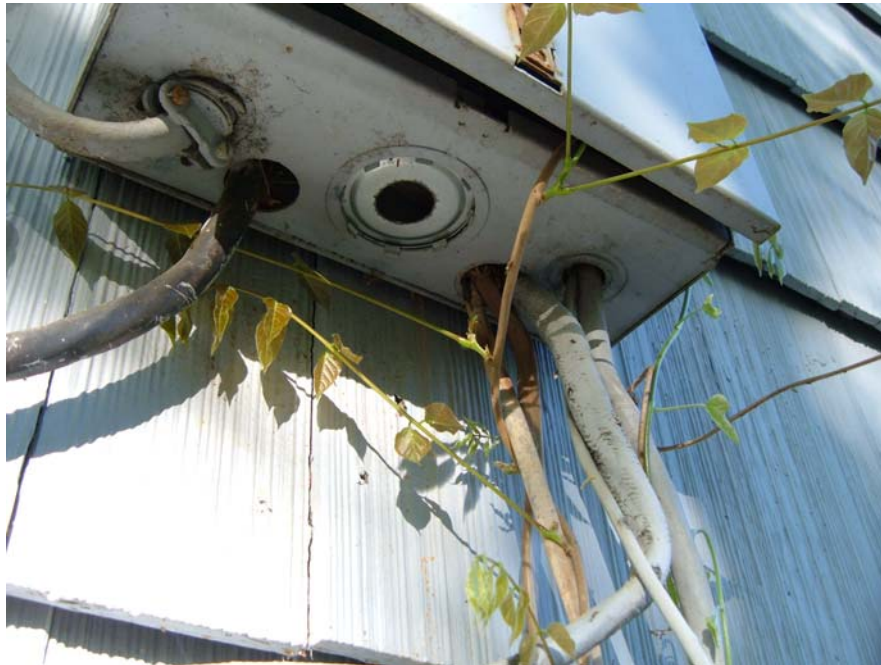
Fig. 14 – Service Enclosure From House AL-8

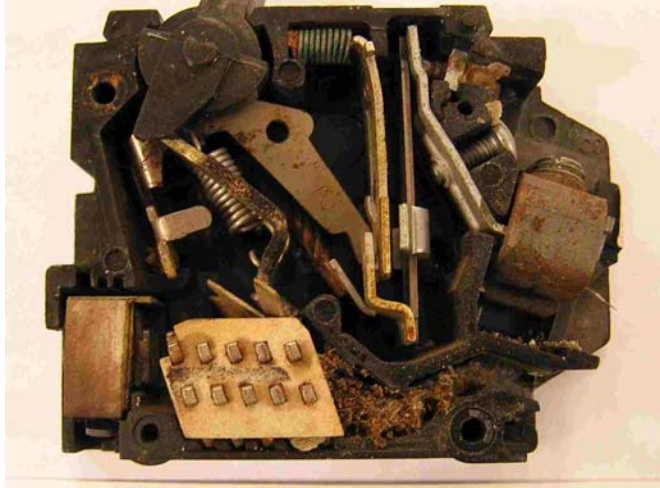
The other four circuit breakers, which were all made by manufacturer B, were examined by UL. A visual inspection of the opened molded cases identified extensive corrosion on many of the operating mechanism and spring parts. Remnants of insect infestation were also noticeable. Circuit breaker AL-9, 1-3, had the stationary and moveable contacts of one pole permanently welded together. All of the other breaker poles had contacts that would separate. Other than circuit breaker AL-9, 1-3, no definitive determination could be made as to the probable cause of the initial calibration failures.

Fig. 15 –House AL-8 Breaker 9-11, Corrosion Damage

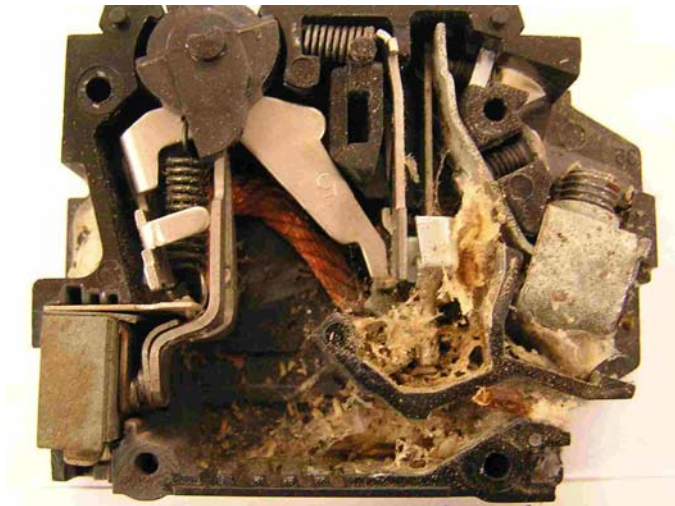
Fig. 16 –House AL-9 Breaker 5-7, Insect Nesting

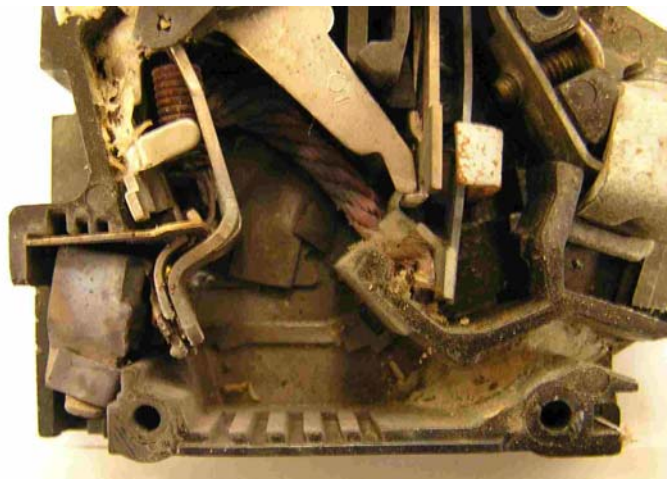
Fig. 17 –House AL-9 Breaker 1-3, Welded Contact

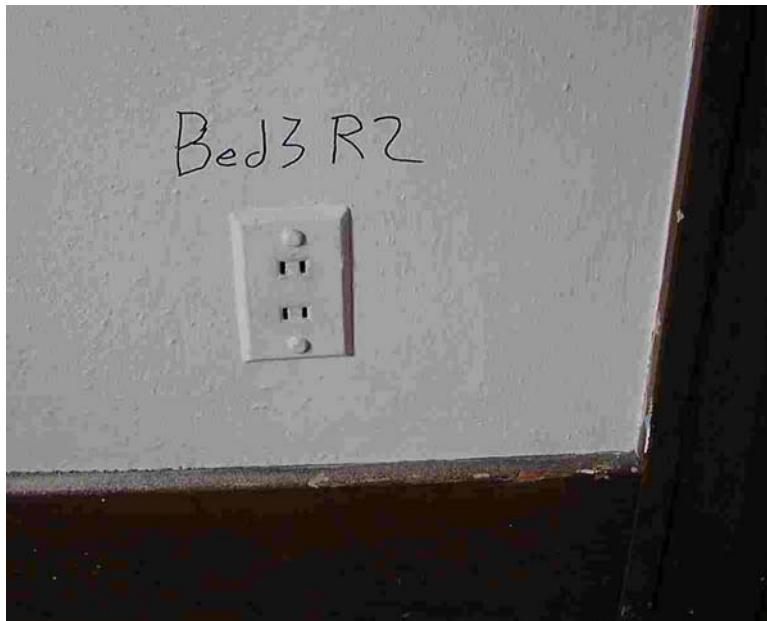
Fig. 18 – House IL-1 Receptacle From the 1920s

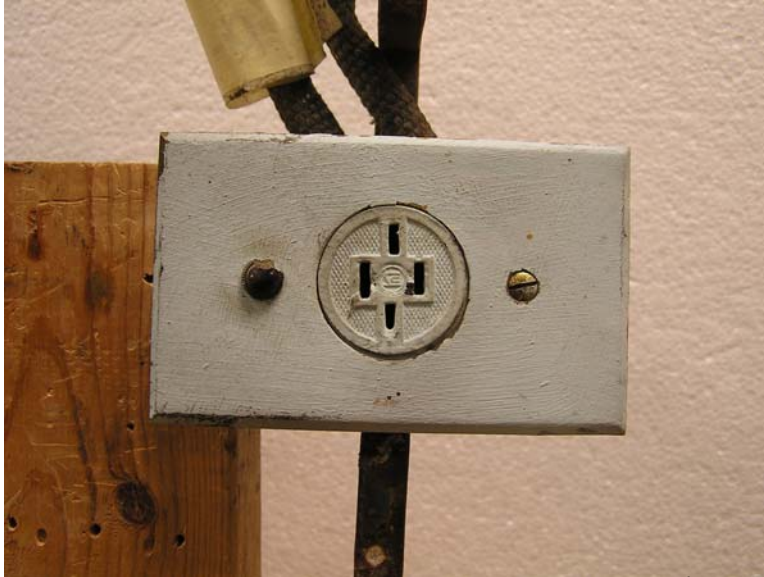
Fig. 19 – House IL-6 Receptacle From the Early 20<sup>th</sup> Century

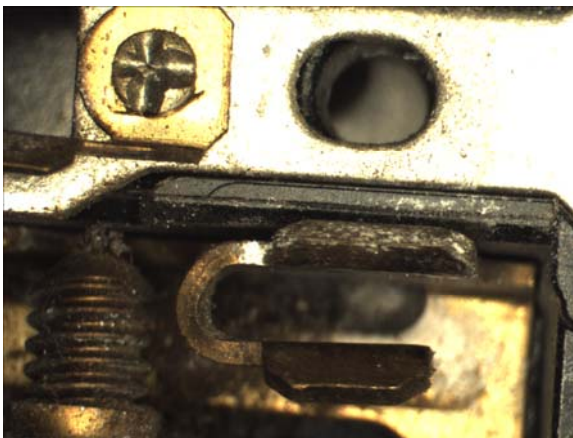
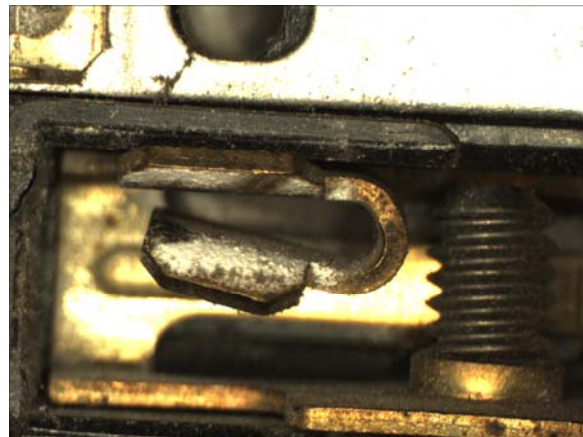
To further explore and compare the loose retention force on some of the receptacles, two receptacles from house AL-6, identified as LR-R3 and DR-R1, were disassembled and examined. The receptacles appeared to be original to the house, and about 30 years old. Receptacle LR-R3 had zero retention force at one of the outlet positions. Closer inspection of the contact gaps at this receptacle location showed them to be 0.083 and 0.095 inches wide. Receptacle DR-R1 had greater than 24 ounces retention force at its outlet positions. Closer inspection of the contact gaps at this receptacle location showed them to be 0.043 and 0.049 inches wide. However, not much was known about any use or abuse that these receptacles may have been subjected to while in service.

Fig. 20a – House AL-6, LR-R3

Fig. 20b – House AL-6, DR-R1

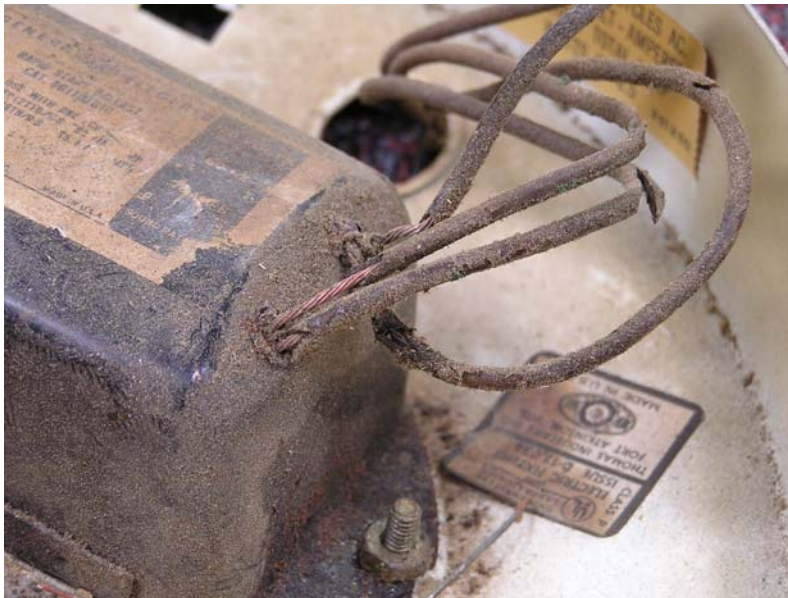
Fig. 21 – House AL-2, Ballast Leads Brittle and Conductor Exposed

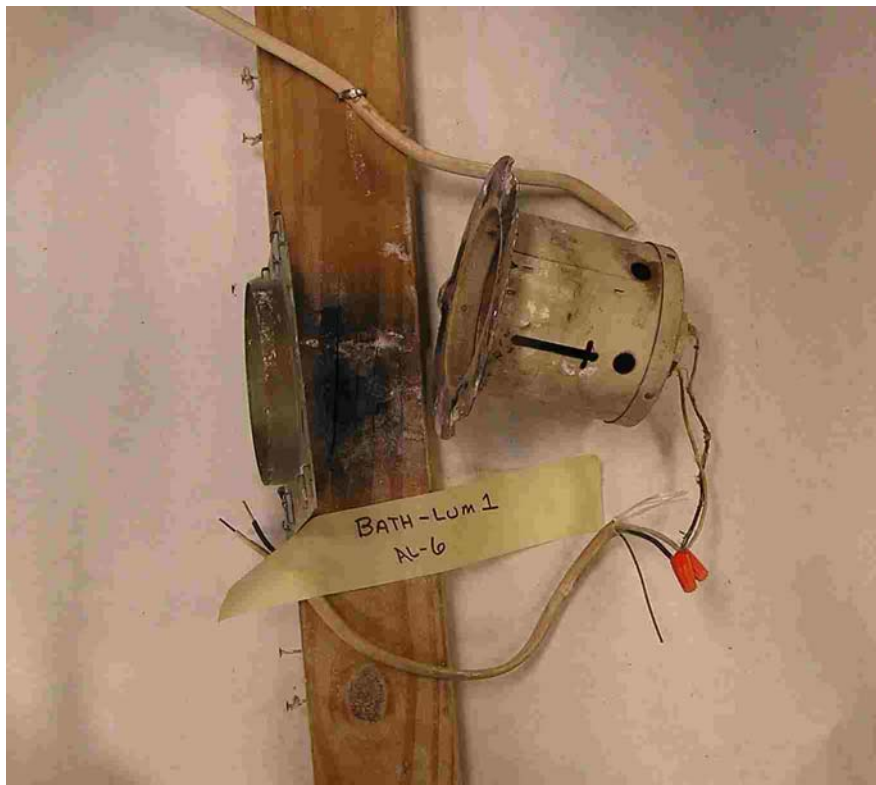
With house AL-6, a recessed ceiling luminaire was located in the shower area. It did not appear to be a complete recessed luminaire fixture, and markings were missing regarding its type, IC or NON-IC. However, there was insulation placed around the fixture and in contact with the metal housing. There was extensive corrosion and evidence of overheating on the painted metal housing and on the wood stud adjacent to the housing. The luminaire wires were brittle and some bare conductor was exposed. There was no junction box and no ground connection to the metal housing. The proper size maximum lamp (60 W) was found installed.

Fig. 22 – Recessed Luminaire From House AL-6

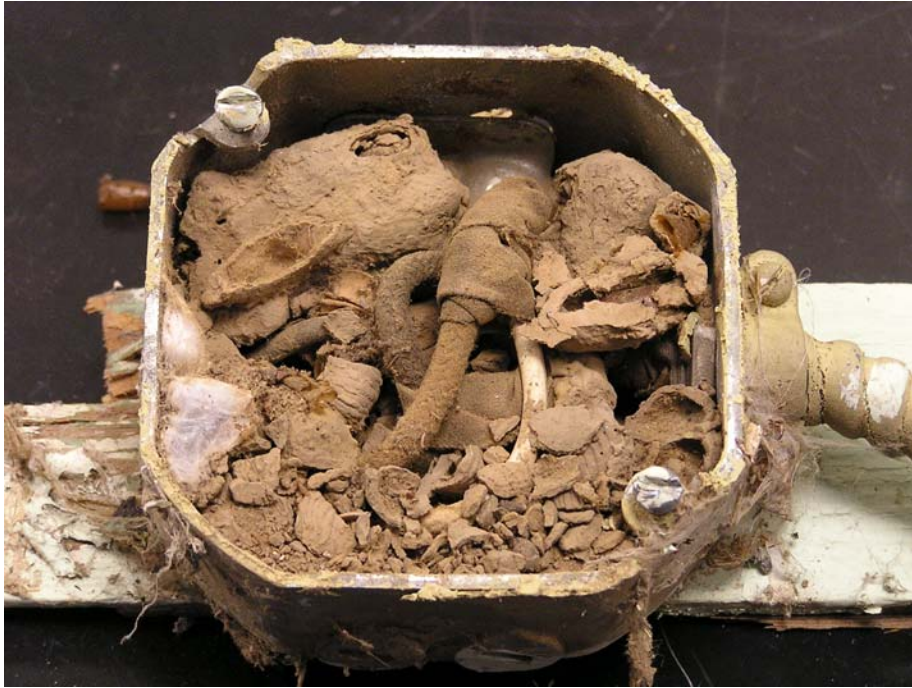
Fig. 23 – Junction Box From House OR-1

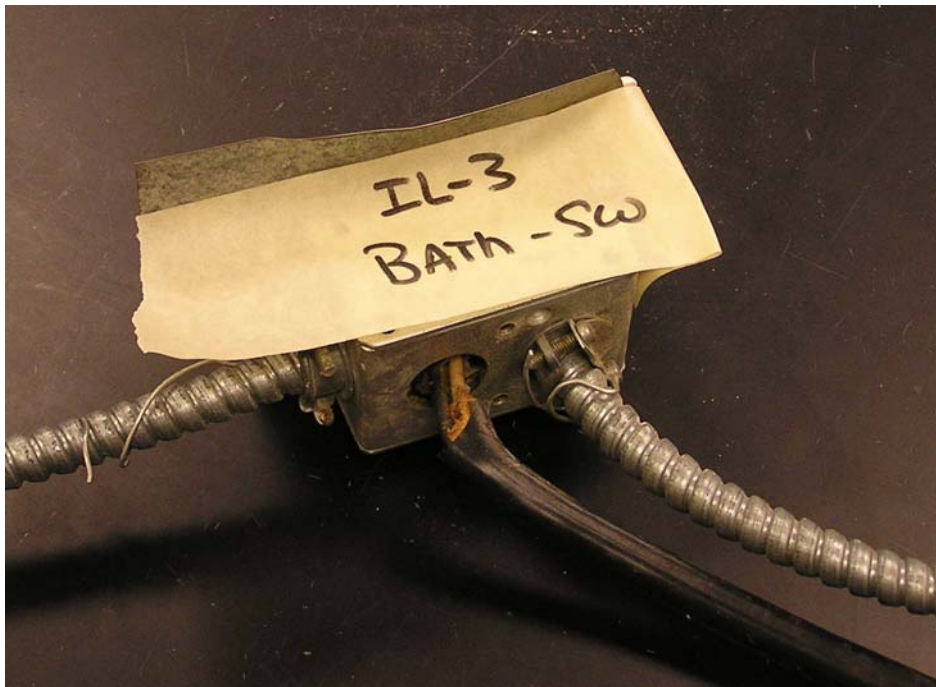
Fig. 24 – Cable Clamp Not Used At House IL-3

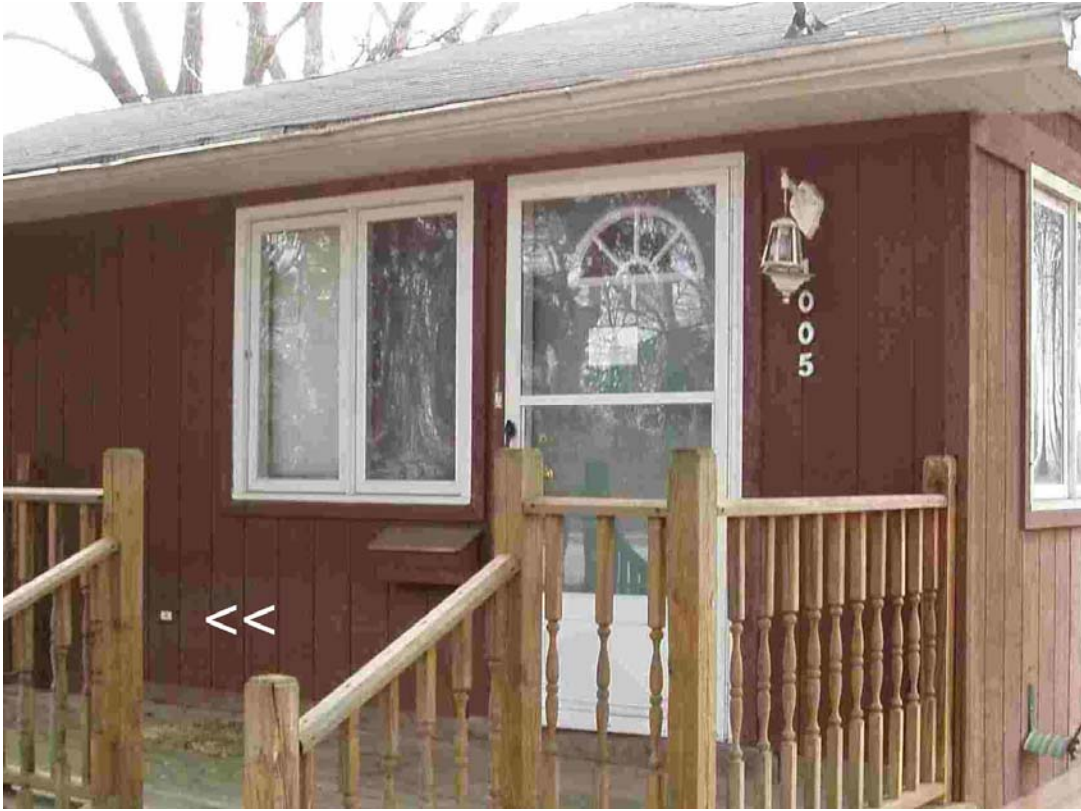
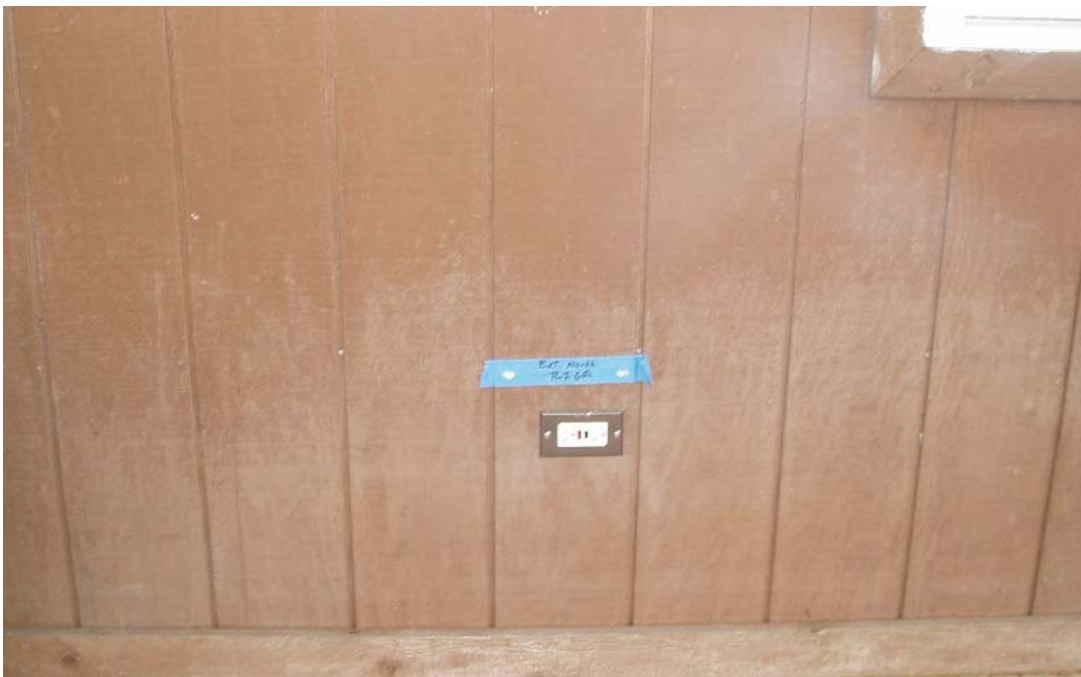
Fig. 25a– House IL-5, Non-Operational GFCI Receptacle With No Outdoor Faceplate or Box Cover

Fig. 25b– House IL-5, Non-Operational GFCI Receptacle With No Outdoor Faceplate or Box Cover (closer view of Fig. 25a)

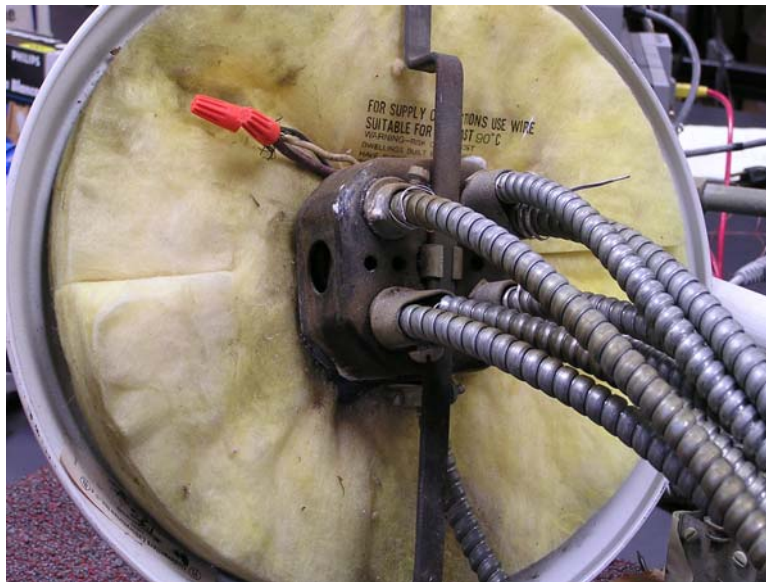
Luminaires are often marked with a minimum supply wire temperature rating, such as 90° C, and a warning that older homes, such as those built before 1985, may have branch circuit conductors with a rating of only 60° C. Luminaires with a marked supply wire temperature rating can become a fire or shock hazard when wired to a branch circuit of a lesser temperature rating. Several houses (AL-2, AL-4, AL-7, IL-4, IL-6, VA-2, and WI-1) were found with luminaires installed on branch circuit supply wires with a temperature rating less than what they were marked for.

Fig. 26 – From Pilot Project House, 60° C Rubber Supply Conductors

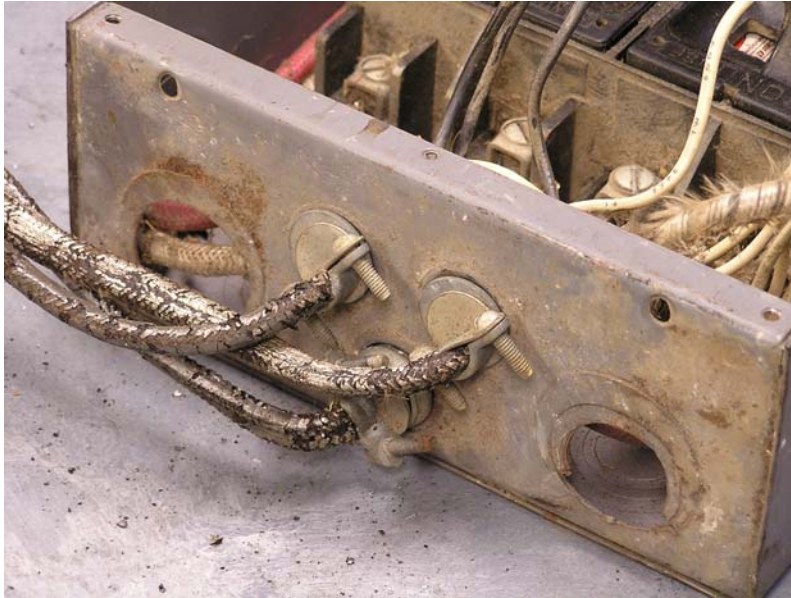
In Sec. 110.12(A) the *Code* says that unused openings shall be closed to afford protection substantially equivalent to the wall of the equipment. If not closed, these openings can be the source of a shock hazard, or concern for the spread of fire. Several houses (AL-3, AL-4, AL-9, VA-1, VA-2, and VA-3) had boxes with open knock-outs or similar openings.

Fig. 27 – House AL-3, Unused Openings in Enclosure

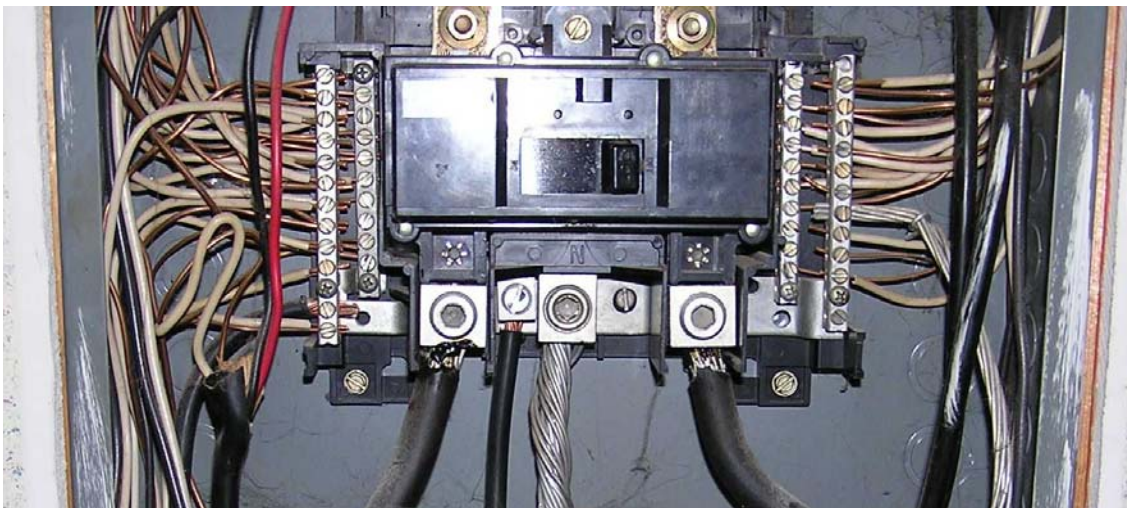
In Sec. 110.14(A) the *Code* says that terminals for more than one conductor shall be so identified. Terminals not tested and used with more than one conductor can be the cause of an improper connection and overheating. In Sec. 408.41 the *Code* also only permits one grounded conductor to be terminated in an individual terminal at a panelboard. Opening a neutral conductor in a multiwire circuit can cause an overvoltage condition that can result in a fire or shock hazard. Several houses (AL-1, AL-9, IL-1, MA-3, NJ-1, NY-1, NY-2, VA-1, and VA-3) had two or more conductors installed in a terminal that was not identified for such use.

Fig. 28 – House VA-1, Multiple Wires Per Terminal

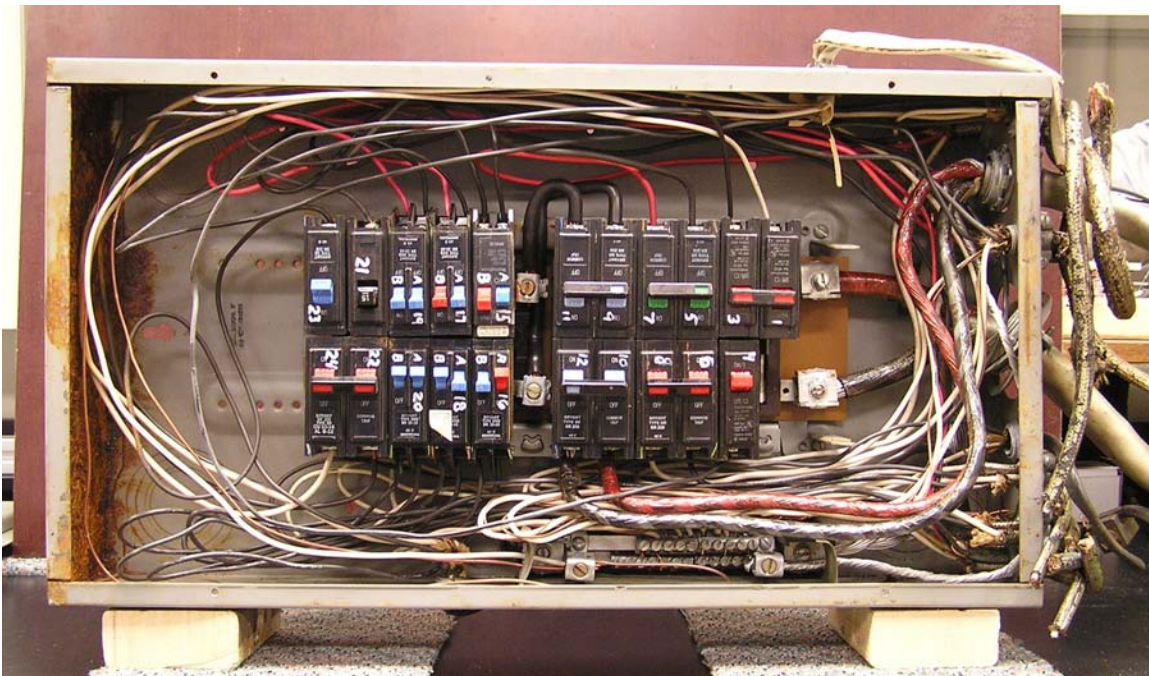
In Sec. 200.7(A) the *Code* says that a conductor with a white or gray covering shall only be used as a grounded circuit conductor. It is important not to confuse grounded and ungrounded conductors, as short circuiting can occur. Also, many people assume that a white conductor is always at ground potential, and less of a shock hazard. Several houses (AL-2, AL-5, AL-7, AL-9, NJ-1, OR-1, OR-2, TX-1, VA-1, and VA-3) used a white conductor as an ungrounded conductor.

Fig. 29 – House NJ-1, White Ungrounded Conductors

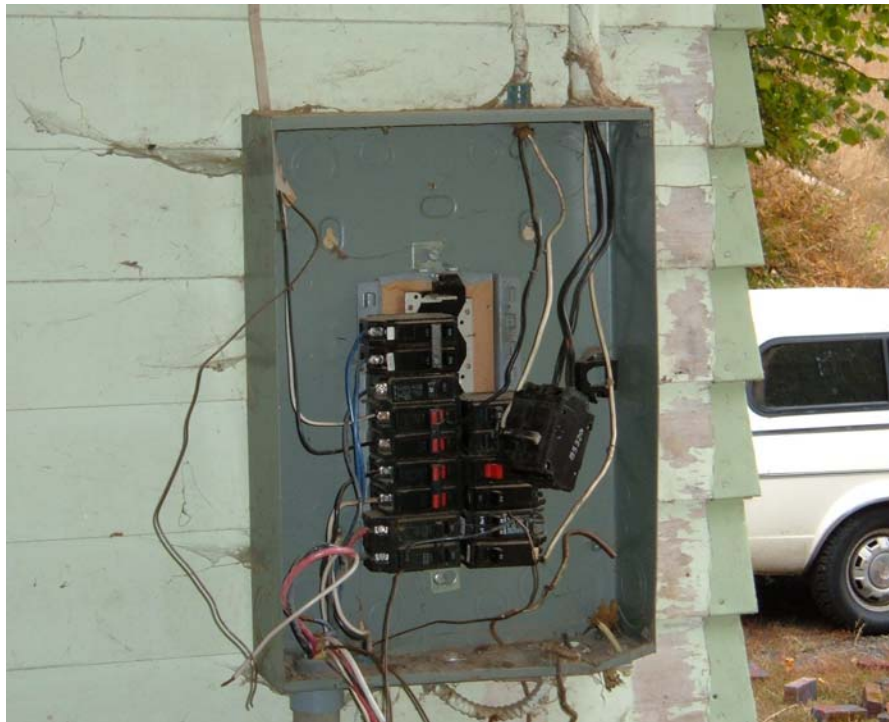
In Sec. 230.70(C) the *Code* says that a service disconnecting means shall be suitable for the prevailing conditions. The service disconnecting means may be the only means to deenergize the entire building in case of fire or other disaster. House OR-1 had the main service disconnect installed outdoors, but the enclosure was not suitable for outdoor use.

Fig. 30 – House OR-1, Main Disconnect Outdoors

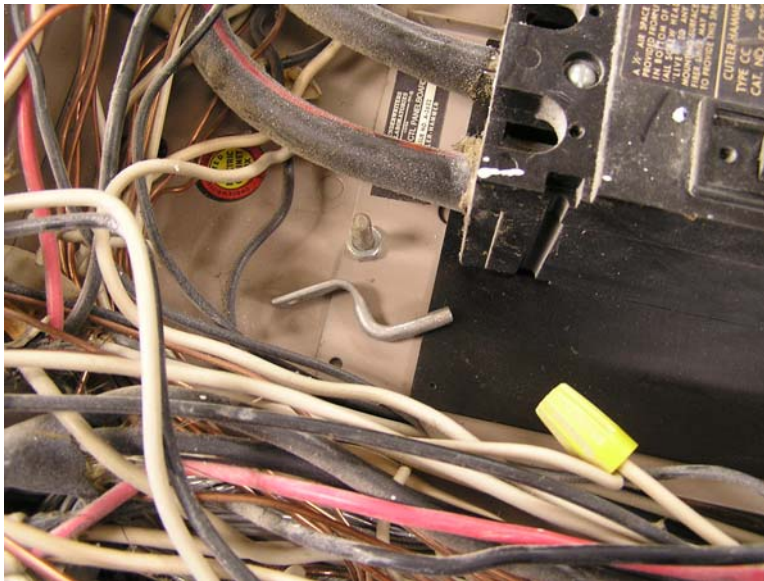
In Sec. 250.24(B) the *Code* says that a main bonding jumper shall be used to connect the equipment grounding conductor and the service-disconnect enclosure to the grounded conductor within the enclosure. Effective system grounding will limit voltage surges during abnormal events, such as lightning, and stabilize the voltage to earth during normal operation. Two houses (VA-1 and VA-3) did not have a main bonding jumper connection at the service.

Fig. 31 – House VA-3, Main Bonding Jumper Not Connected

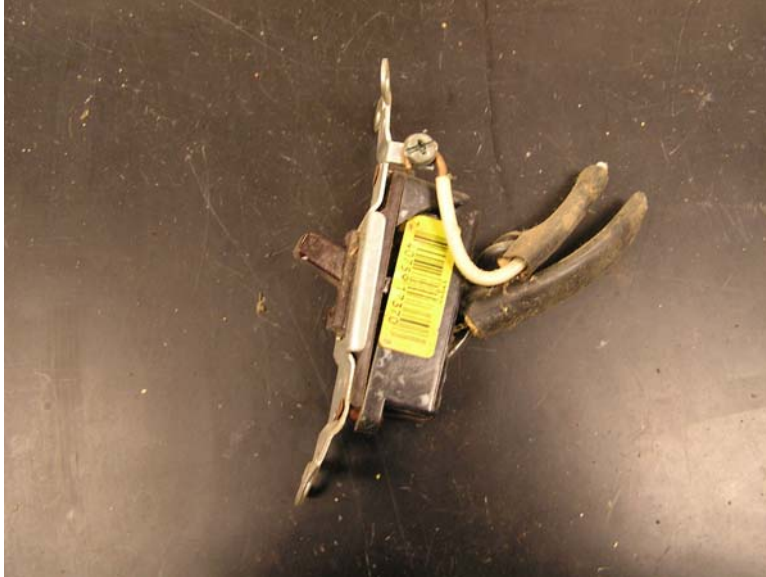
In Sec. 250.119 the *Code* says that equipment grounding conductors shall be bare or be insulated with a continuous green outer surface. It is important not to confuse equipment grounding conductors with other conductors, as a shock hazard could exist. Two houses (AL-2 and TX-1) had insulated equipment grounding conductors that were a color other than green.

Fig. 32 – House TX-1, White Colored Grounding Conductor

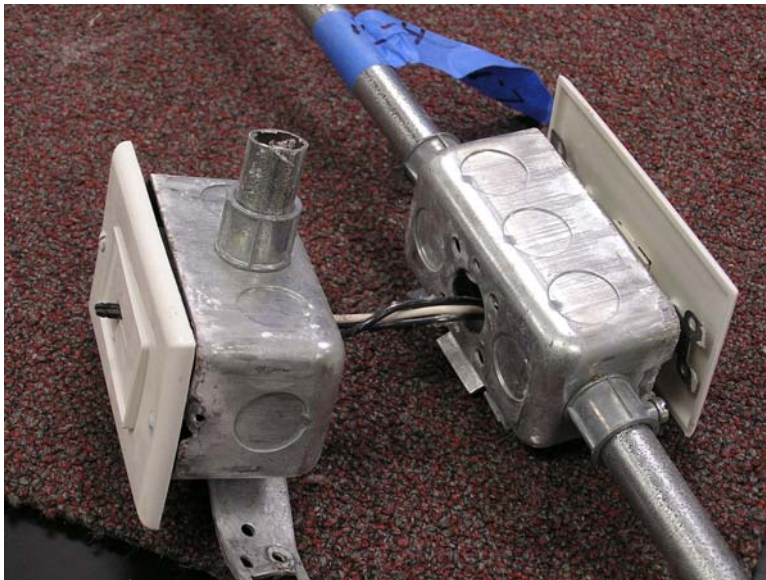
In Sec. 300.3 the *Code* says that single conductors shall only be installed where part of a recognized wiring method. Wires not installed in this manner can become a fire or shock hazard. Two houses (AL-7 and IL-4) had conductors that were open and not in a cable or raceway.

Fig. 33 – House IL-4, Open Conductors In Wall Between Boxes

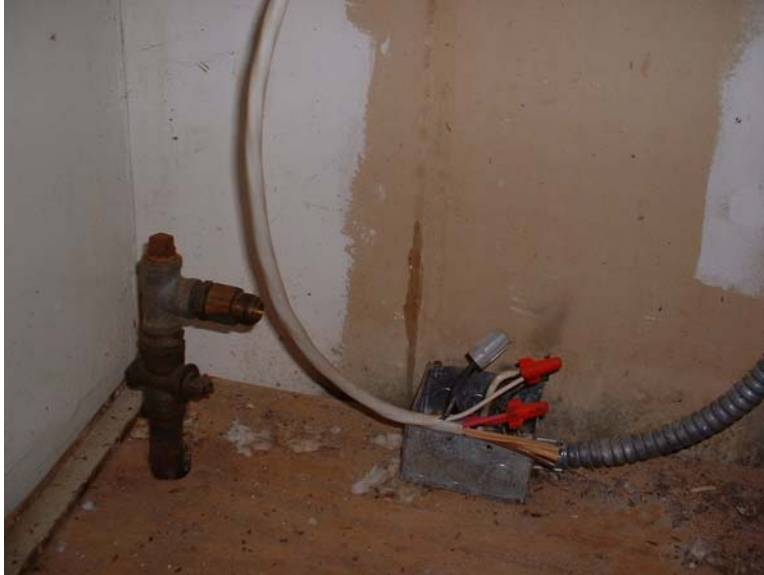
In Sec. 300.11 the *Code* says that boxes shall be securely fastened in place. If a box is not supported, strain could be placed on the wires, resulting in a fire or shock hazard. Two houses (AL-1 and WI-1) had outlet boxes that were unsecured.

Fig. 34– House AL-1, Unsupported Box (Also No Box Cover)

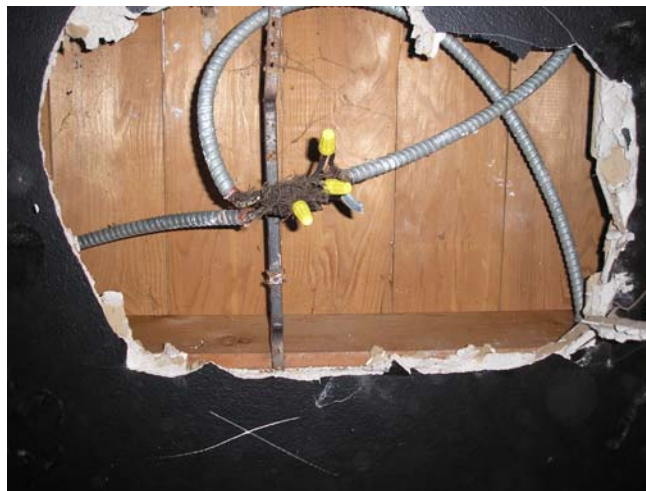
In Sec. 300.15 the *Code* says that a box or conduit body shall be installed for each conductor splice or outlet point. Open splices can be the cause of a fire or shock hazard. Several houses (AL-1, AL-5, AL-6, AL-8, OR-1, OR-2, and WI-1) had open splices in walls or ceilings without the use of outlet boxes.

Fig. 35 – House WI-1, Open Splices in Ceiling
