# **Residential Electrical System Aging Research Project**

## **Technical Report**

July 1, 2008

Prepared by:  
David A. Dini, P.E.  
Underwriters Laboratories Inc.

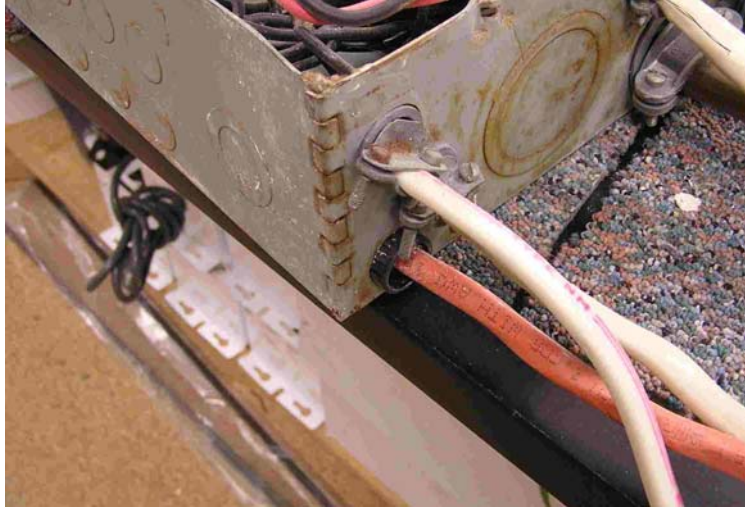
In Sec. 314.17(A) the *Code* says that an opening through which conductors enter boxes shall be adequately closed. In Sec. 312.5(C) the *Code* also says that where cable is used, each cable shall be secured to the cabinet or enclosure. Conductors or cables that are not adequately secured can cause strain to be put on the wires and its terminations. Several houses (AL-1, AL-3, AL-4, AL-8, AL-9, IL-3, MA-3, VA-1, VA-2) had one or more examples where cable clamps were not provided.

Fig. 36 – House MA-3, Cable Clamp Not Provided

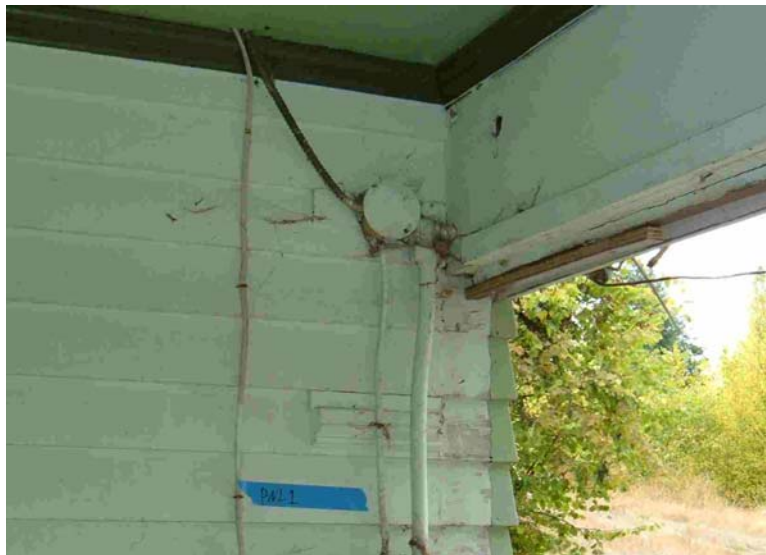
In Sec. 320.12 the *Code* says that AC cable shall not be used in wet or damp locations. AC cable is not watertight, and if exposed to water can become a shock or fire hazard. Moisture can also cause the armor to become compromised and lose its ability to be an effective equipment grounding path. House OR-1 had AC cable installed outdoors.

Fig. 37 – House OR-1, AC Cable Installed Outdoors

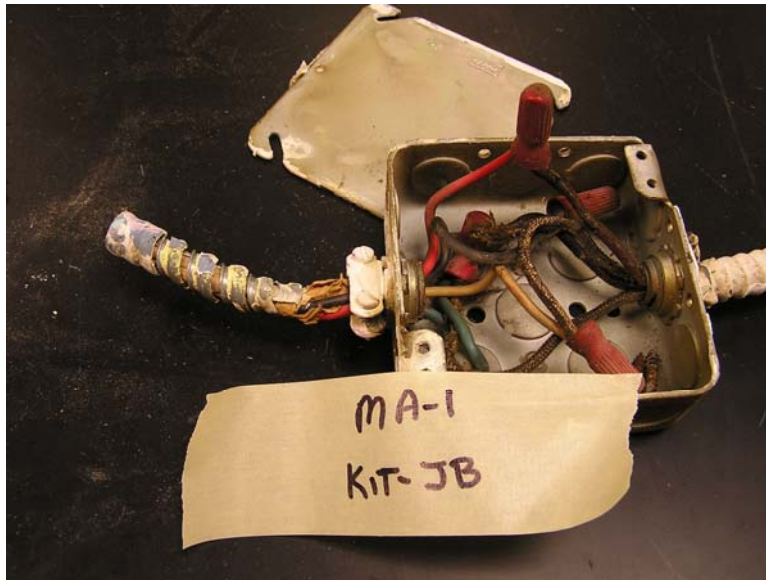
In Sec. 320.40 the *Code* says that AC cable at boxes and fittings shall be provided with an insulating bushing between the conductors and the armor. At a cut end the AC cable armor can be sharp, and this can damage the conductor insulation if not protected. Damaged conductor insulation can be the cause of a fire or shock hazard. Several houses (IL-1, IL-2, IL-3, MA-1, OR-1, and WI-1) had examples of AC cable being used without insulating bushings installed.

Fig. 38 – House MA-1, No Insulating Bushing Installed With AC Cable

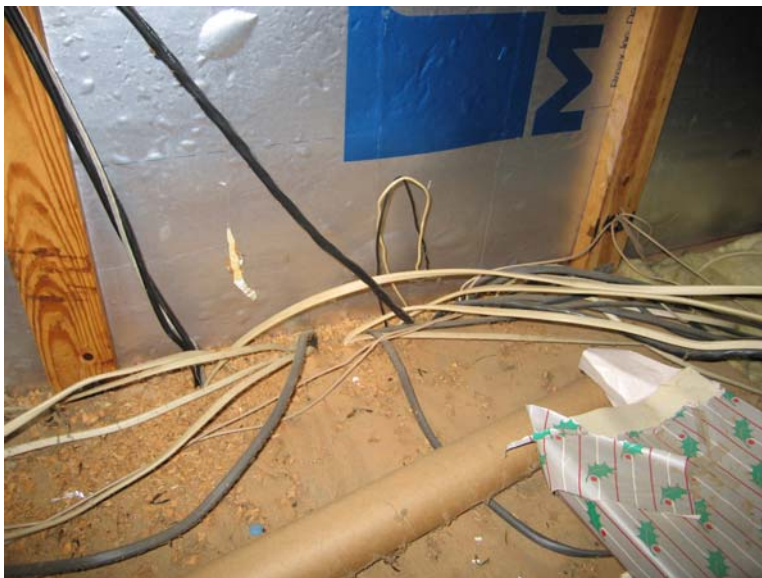
In Sec. 334.30 the *Code* says that NM cable shall be supported by staples or the like every 4-1/2 feet, and within 12 inches of every outlet box or cabinet. Unsupported cable can become damaged or strained, and become a shock or fire hazard. Several houses (AL-5, NY-2, OR-1, VA-1, and VA-3) had examples where NM cable was installed unsupported.

Fig. 39 – House VA-1, NM Cable Not Supported by Staples

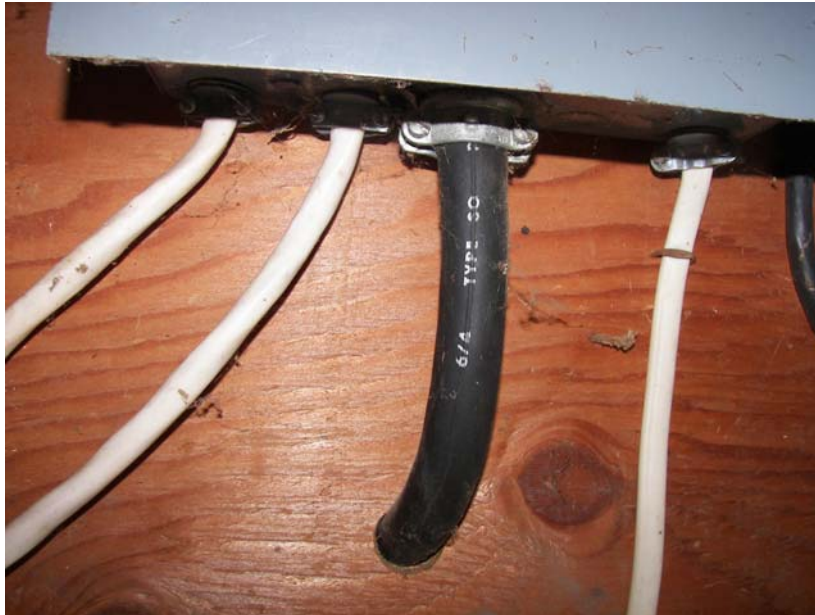
In Sec. 400.8 the *Code* says that flexible cords and cables shall not be used as a substitute for fixed wiring. It also states that they should not be run through holes in walls or ceilings, or attached to building surfaces. Flexible cords and cables are not subjected to the more rigid mechanical testing that fixed wiring methods, such as NM and AC cable or EMT, are subjected to. Several houses (AL-1, AL-4, AL-6, AL-7, AL-8, IL-3, NY-2, OR-1, and WI-1) used flexible cord or cable as a substitute for fixed wiring.

Fig. 40 – House NY-2, Type SO Flexible Cord From Panelboard

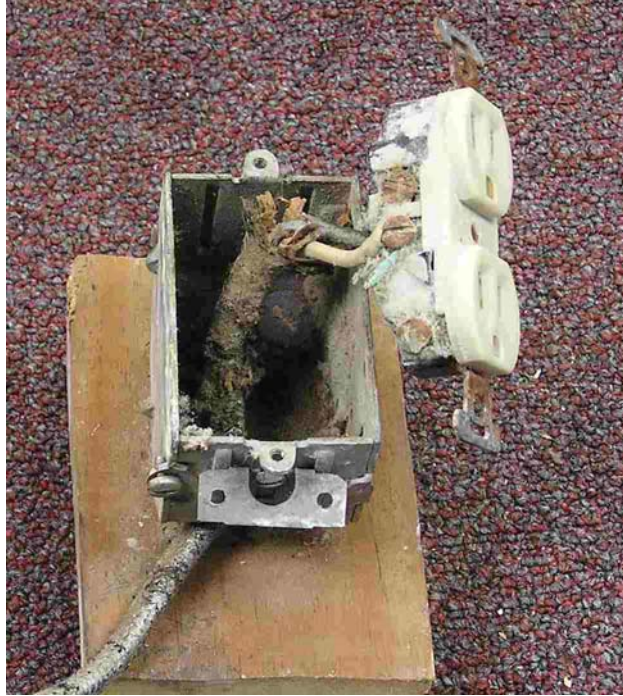
In Sec. 406.3(B) the *Code* says that receptacles that have equipment grounding contacts shall have those contacts connected to an equipment grounding conductor. If cord- and plug-connected equipment that is intended to be grounded is connected to a receptacle that does not provide a suitable equipment grounding path, a shock hazard could exist. Several houses (AL-1, AL-3, AL-8, AL-9, TX-1, and VA-1) had grounding type receptacles (3-prong) installed in a branch circuit that did not have an equipment grounding conductor.

Fig. 41 – House AL-4, Grounding Type Receptacle Without Ground

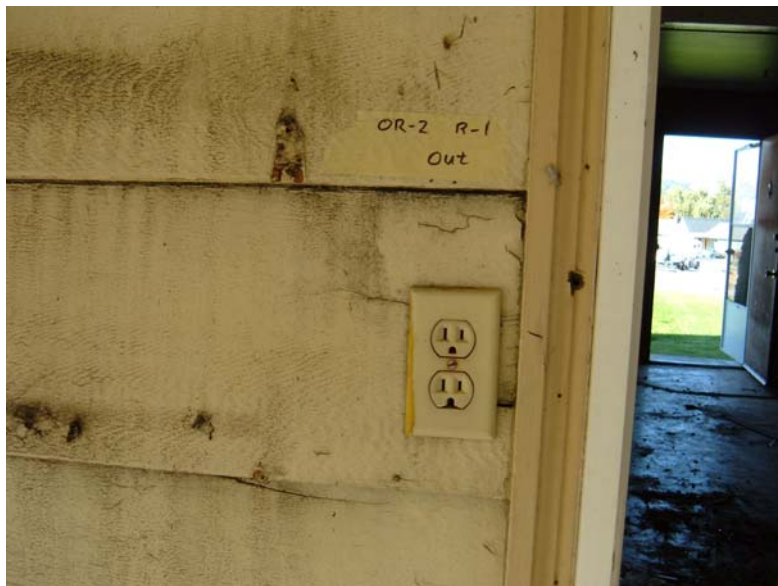
In Sec. 406.8 the *Code* says that receptacles installed outdoors shall have an enclosure that is weatherproof. If water gets into the contacts of a receptacle, it can become a fire or shock hazard. Several houses (IL-5, OR-1, and OR-2) had outdoor receptacles that were not in weatherproof enclosures.

Fig. 42 – House OR-2, Open Receptacle Outdoors

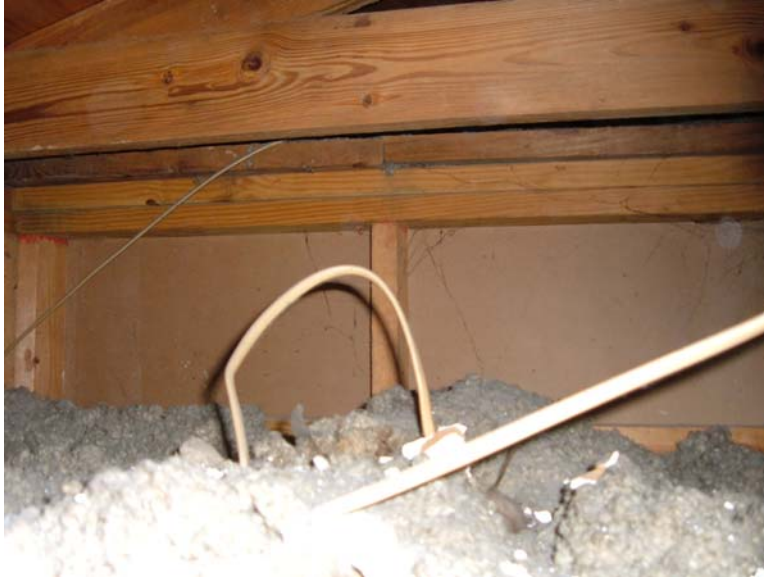
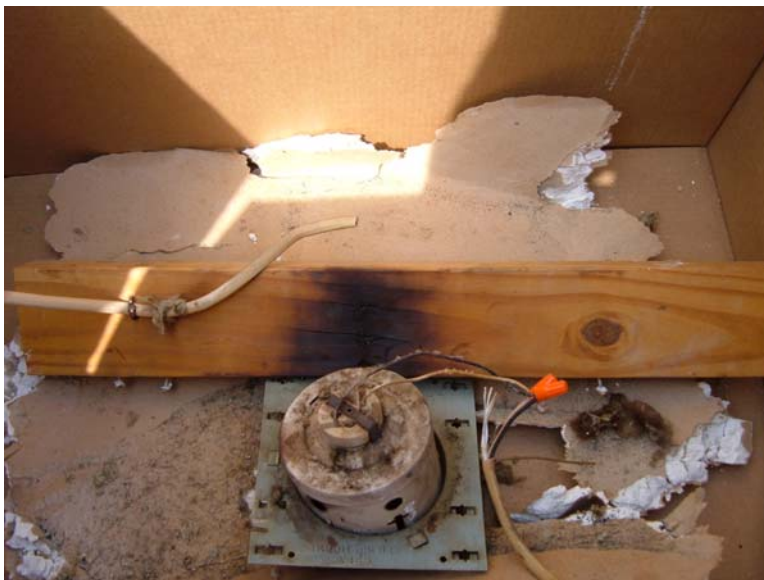
In Sec. 410.116(A) the *Code* says that a recessed luminaire that is not intended for contact with insulation shall have all recessed parts spaced  $\frac{1}{2}$  inch from combustible materials. It also says that thermal insulation shall not be installed above a recessed luminaire or within 3 inches of the enclosure unless identified for contact with insulation. Recessed luminaires that are not marked type IC are not temperature tested with surrounding thermal insulation, and can become a fire hazard if installed in this manner. House AL-6 had an unmarked recessed ceiling luminaire installed in a shower area against a wall stud and surrounded with insulation.

Fig. 43a – House AL-6, Thermal Insulation Above Recessed Luminaire

Fig. 43b – House AL-6, Recovered Recessed Ceiling Luminaire
