# Piece by piece restoration

*The restoration of the Beloit College's Logan Museum required intense attention to detail, right down to the individual pieces of stone*

## Logan Museum, Beloit College Beloit, WI

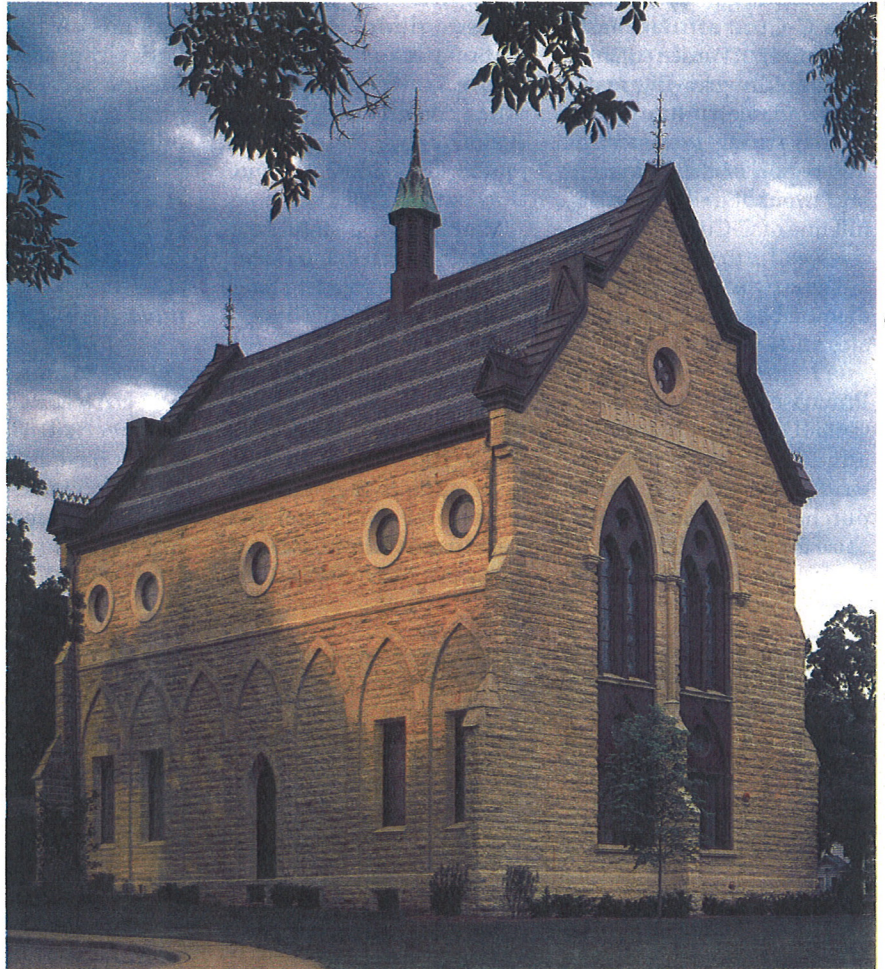
The limestone exterior at the Logan Museum was cleaned, and one wall was taken down and re-installed.

To repair the 18-inch (457 mm) bulge in the west wall, each stone in the problem area was removed, numbered and returned to its original location. According to William Ballou of Ballou Masonry, which completed the work, the stone itself showed very little deterioration. "We put very few

To enhance the appearance of the existing limestone, each piece was lightly pressure washed with a 20-degree nozzle. This, according to Ballou, was enough to remove the residue from the entire building.

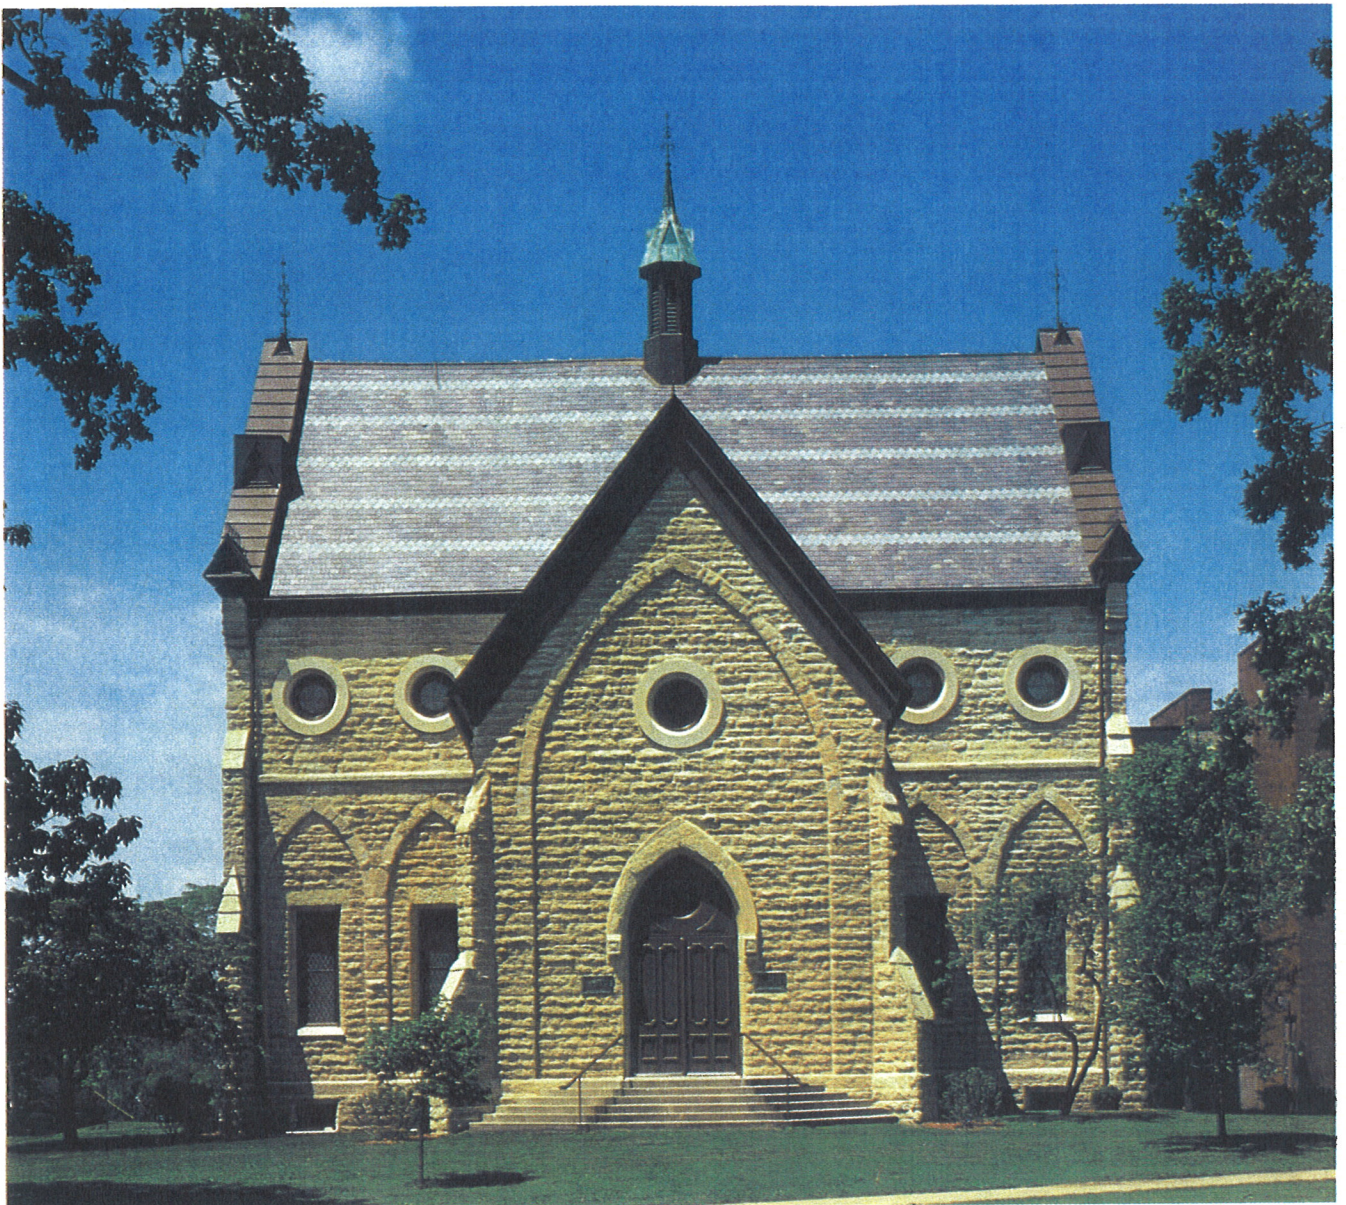
The slate roofing and round limestone window frames were replaced.

While much of the veneer was saved, all of the round limestone window frames were replaced with stone conforming to original profiles from nearby original quarries, and the entire exterior was repointed. "The most difficult part of the installation was fitting the round window trims, which weighed 3,000 pounds [1,360 kg] each," Ballou said. The circular trims were made from four separate pieces which were assembled on the ground, lifted into place and anchored with stainless steel dowels.

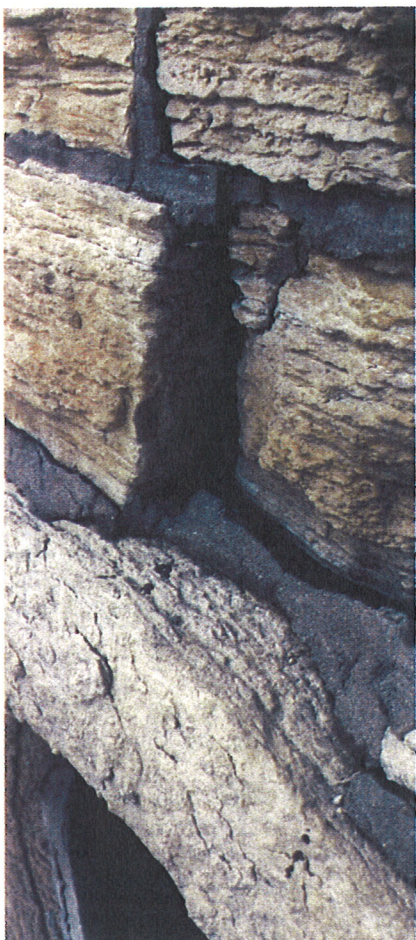
**There was substantial displacement of the stone above the window head, as well as evidence of previous pointing. Leaks were observed just above this area.**

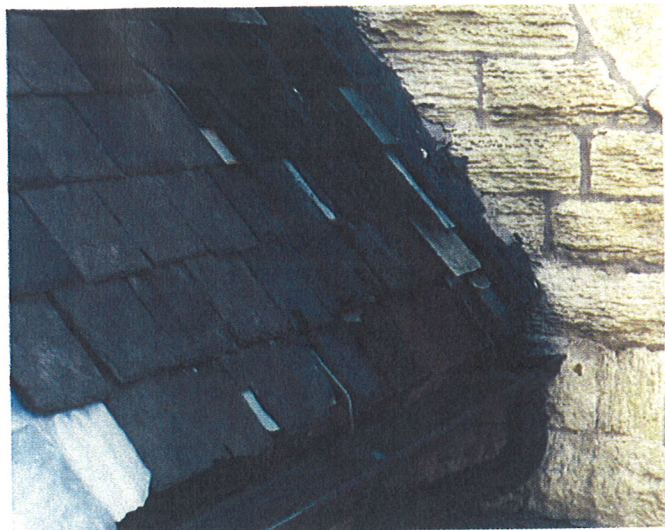
**Areas of the slate roof had little or no flashing, and had been repaired a number of times in the past. Many of the slate roofing pieces had been turned over and re-laid, and a few were broken or missing.**

The slate roof also had to be replaced. “The internal guttering system had failed, which is why a lot

of the water got into the stone in the first place," Saylor said. Additionally, many of the slate roofing pieces had been turned over and re-laid, and a few were broken or missing.

The slate was set with the traditional method of hammering. Saylor noted that there was some roof deck replacement, and ice shields were installed under the roofing to protect future damage to the edges of the slate. "Where the roof had failed the most was at the gutters, so we had large gutters built at the bottoms of the roof slopes," he said. "Dealing with the roof was the first step in assuring the other problems wouldn't get worse."
