# **Residential Electrical System Aging Research Project**

## **Technical Report**

July 1, 2008

Prepared by:  
David A. Dini, P.E.  
Underwriters Laboratories Inc.

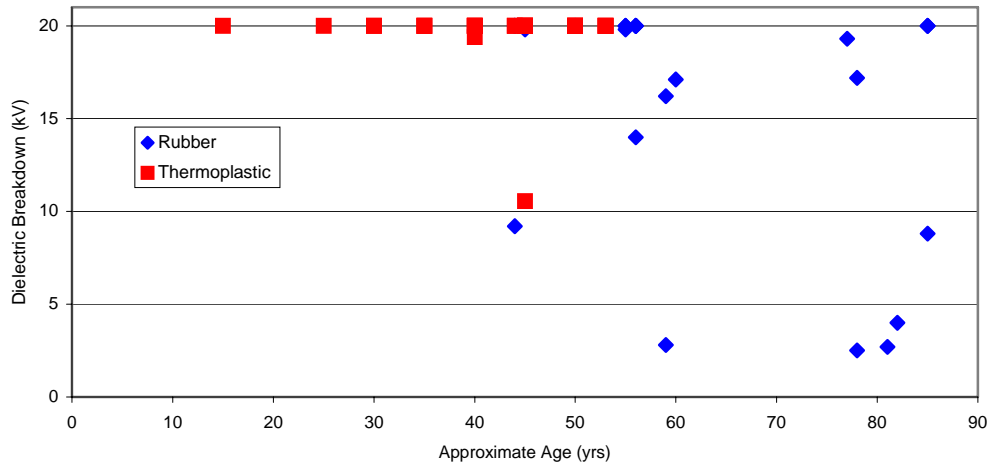
Fig. 1 - Dielectric Test Results vs Age

The trends clearly showed a reduction in dielectric strength and bend strength with age; however, this may have been largely due to the inherent property characteristic differences between older rubber insulations and newer thermoplastic insulations. In general, thermoplastic insulations performed very well with age. Figures 1 and 2 from that study are shown here for reference.
